## IMMEDIATE STOP USE AND INSPECT NOTICE FOR PARK TOOL CRANK PULLERS

**PART NUMBER AFFECTED:** Park Tool CCP-22, CCP-44 and CWP-7 Crank Pullers.

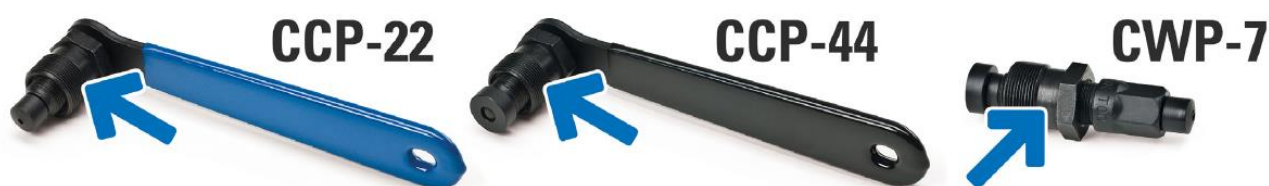
**INSPECTION OF TOOL:** To see if your tool is affected, locate the nut on each of the tools per the images below and inspect the threading.

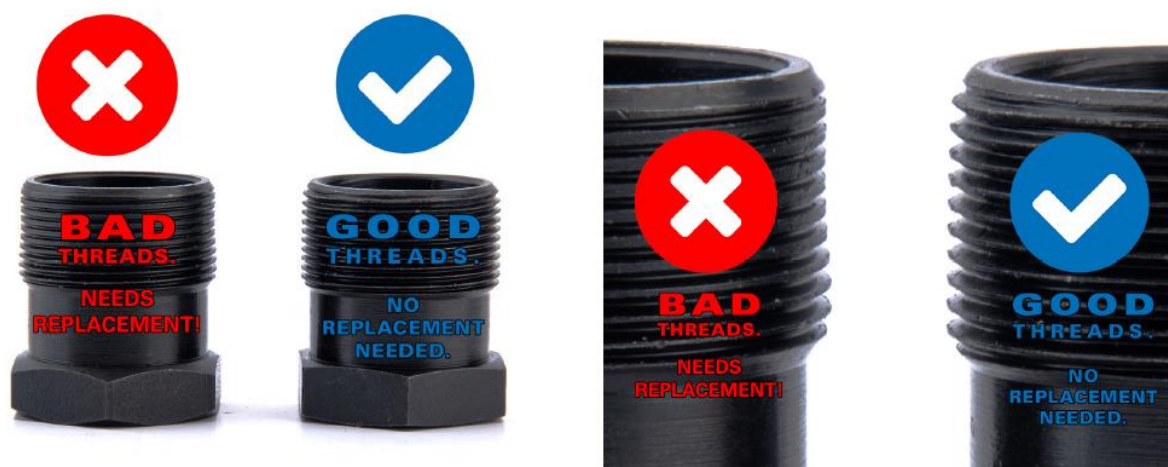
Bad threads will have a flat peak, and the improper thread peaks will extend almost halfway down the threading of the nut. The non-affected tools have sharper and consistent thread peaks throughout the length of the nut, as shown in the picture.

IF YOU HAVE CHECKED YOUR PULLER AND NEED A REPLACEMENT NUT,  
PLEASE CONTACT US IMMEDIATELY.
